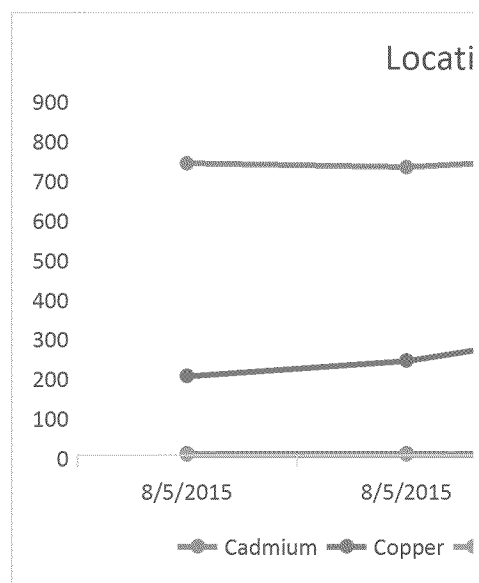
on: A68

Location ID	Date Sampled	Cadmium	Copper	Lead	Manganese	Zinc
A68	8/5/2015	0.828	3.45	0.232	737	199
A68	8/5/2015	0.815	3.16	0.283	727	238
A68	8/5/2015	0.974	3.52	0.82	757	324
A68	8/6/2015	0.85	3.26	0.329	817	326

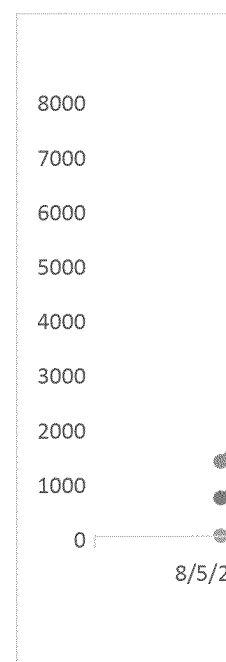
Location: A72

Location ID	De Sampled	Cadmium	Copper	Lead	Manganese	Zinc
A72	8/5/2015	1.81	9.27	0.225	1370	699
A72	8/5/2015	15.2	1410	50.7	6650	4020
A72	8/5/2015	4.29	205	3.12	1810	1210
A72	8/5/2015	2.59	11.4	0.118	1320	733
A72	8/6/2015	2.11	7.63		1160	609
